32nd Annual **INCOSE**
international symposium
hybrid event

Takaharu Igarashi and Karen Marais
School of Aeronautics and Astronautics, Purdue University

Construction System Failures: Frame Notation of Project Pathogens and their Propagation Across Time and System Hierarchy

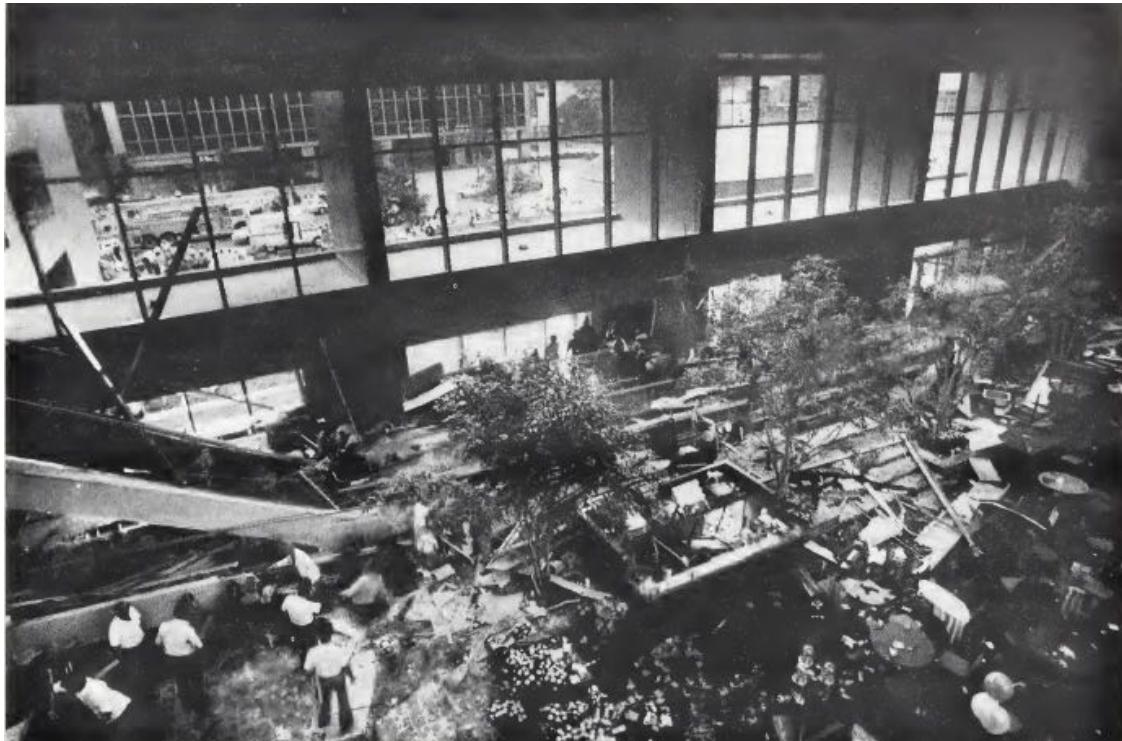
Kansas City Hyatt Regency
Walkway bridge collapse, 1981^[1]

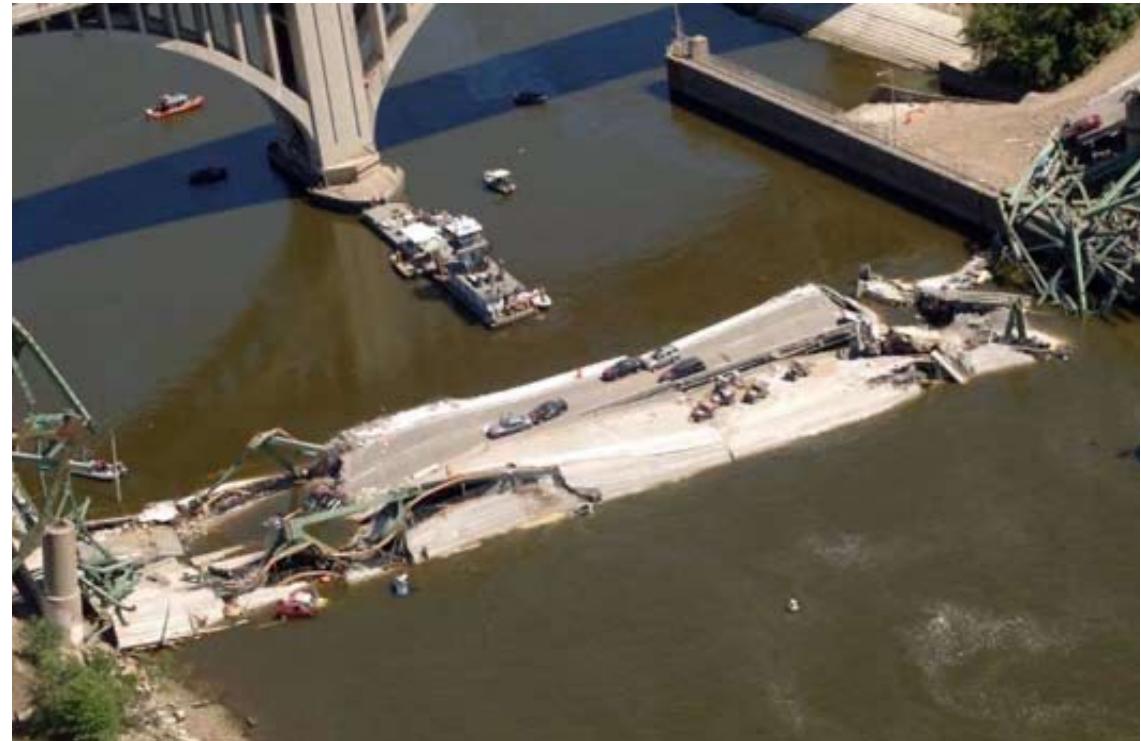
Minneapolis I-35W
Highway bridge collapse, 2007^[2]

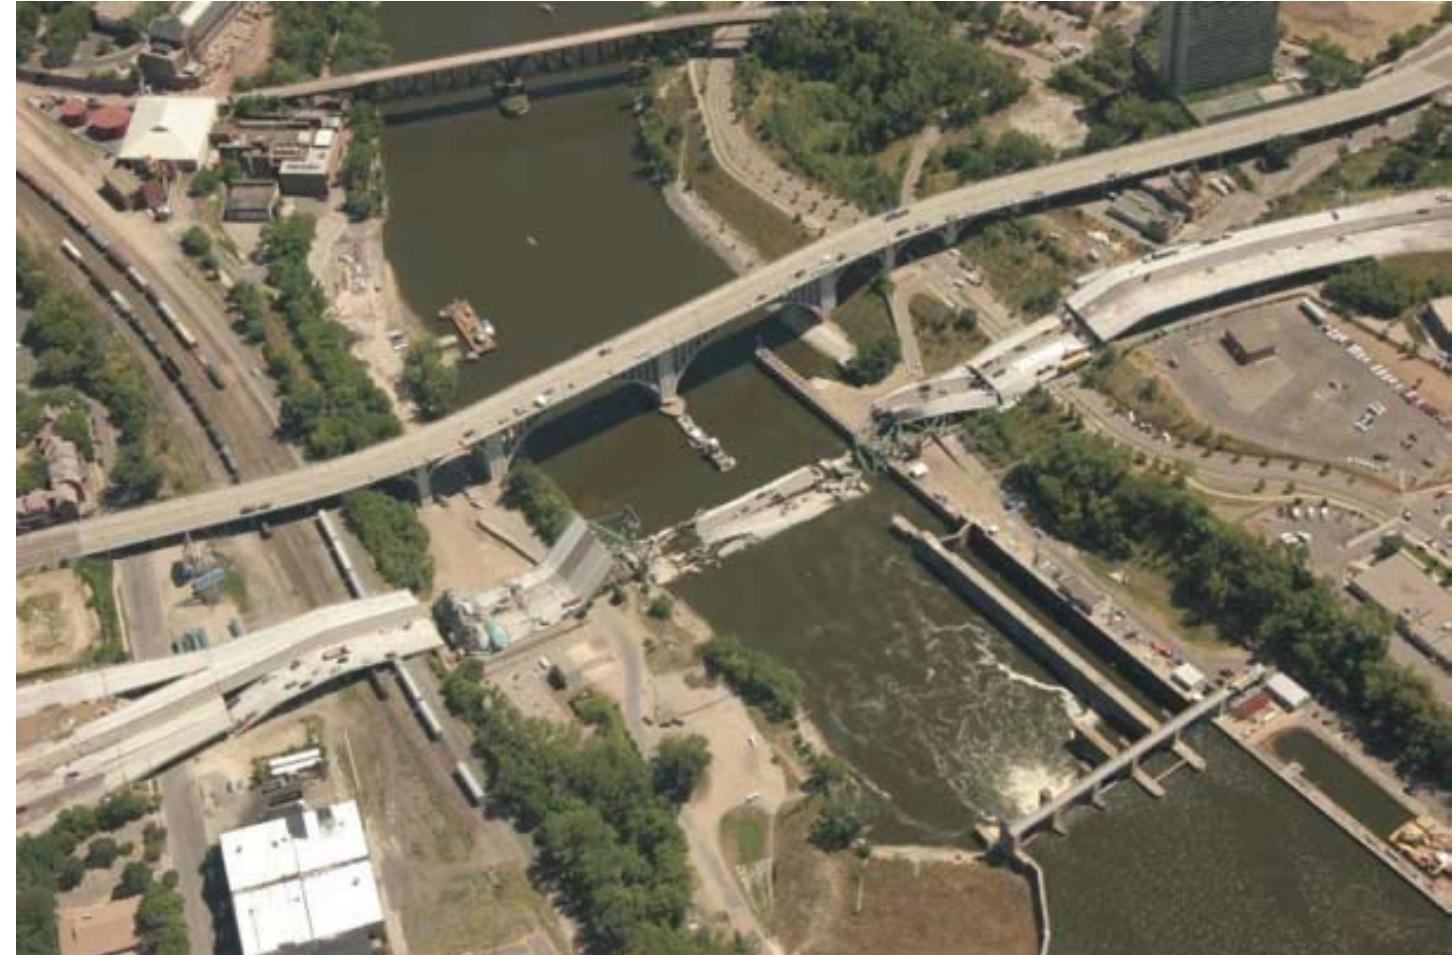
- August 1, 2007
- ~1,000-ft span collapsed
- 111 vehicles involved
- 145 injuries, 13 fatalities
- Repaving work underway
- Bridge opened in 1967

Aerial view of the collapsed bridge^[2]

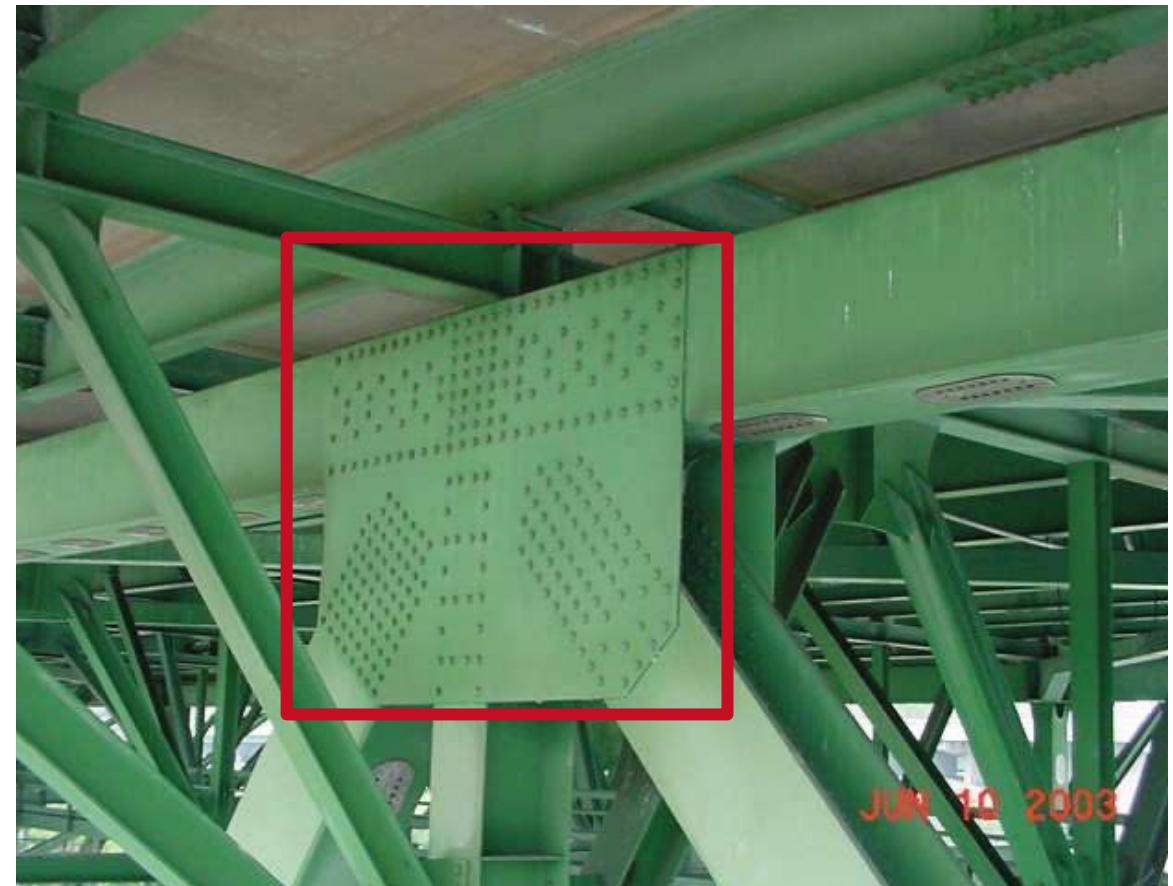
1. Defective gusset plates

- Insufficient load capacity
- Omission of calculations

Typical gusset plate of the bridge^[2]

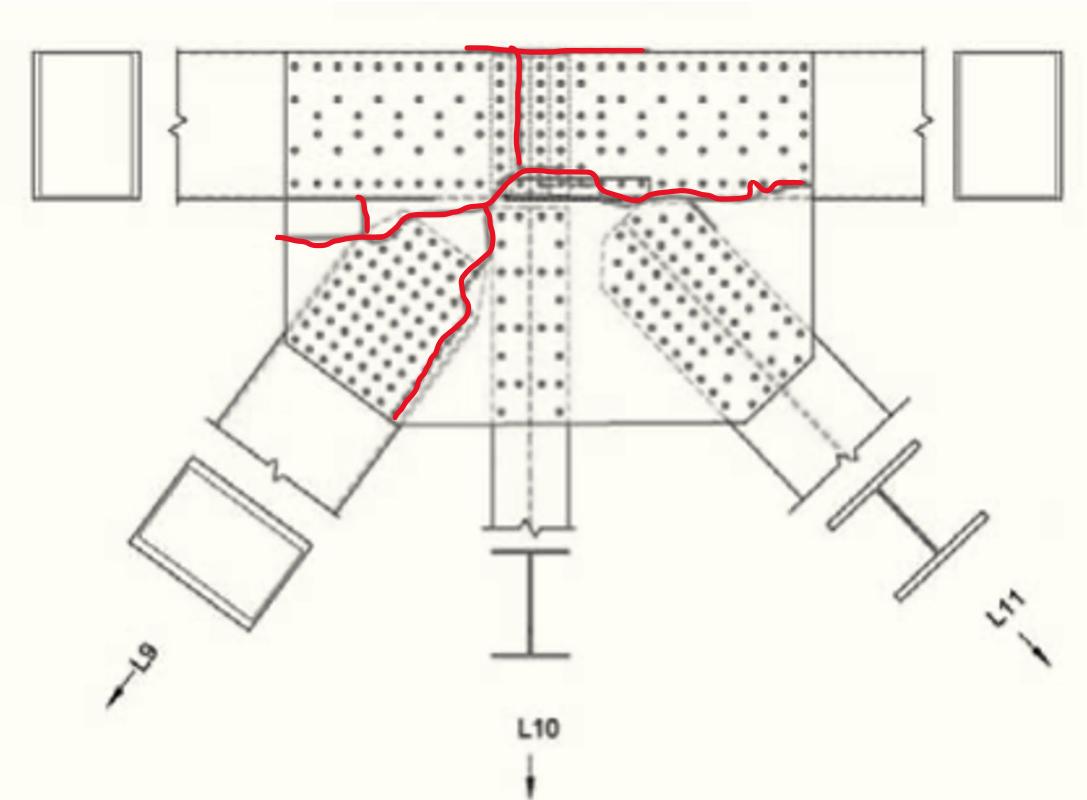
2. Failed inspections

- Gusset plate excluded from inspection guidelines

Gusset plate with fractures^[2]

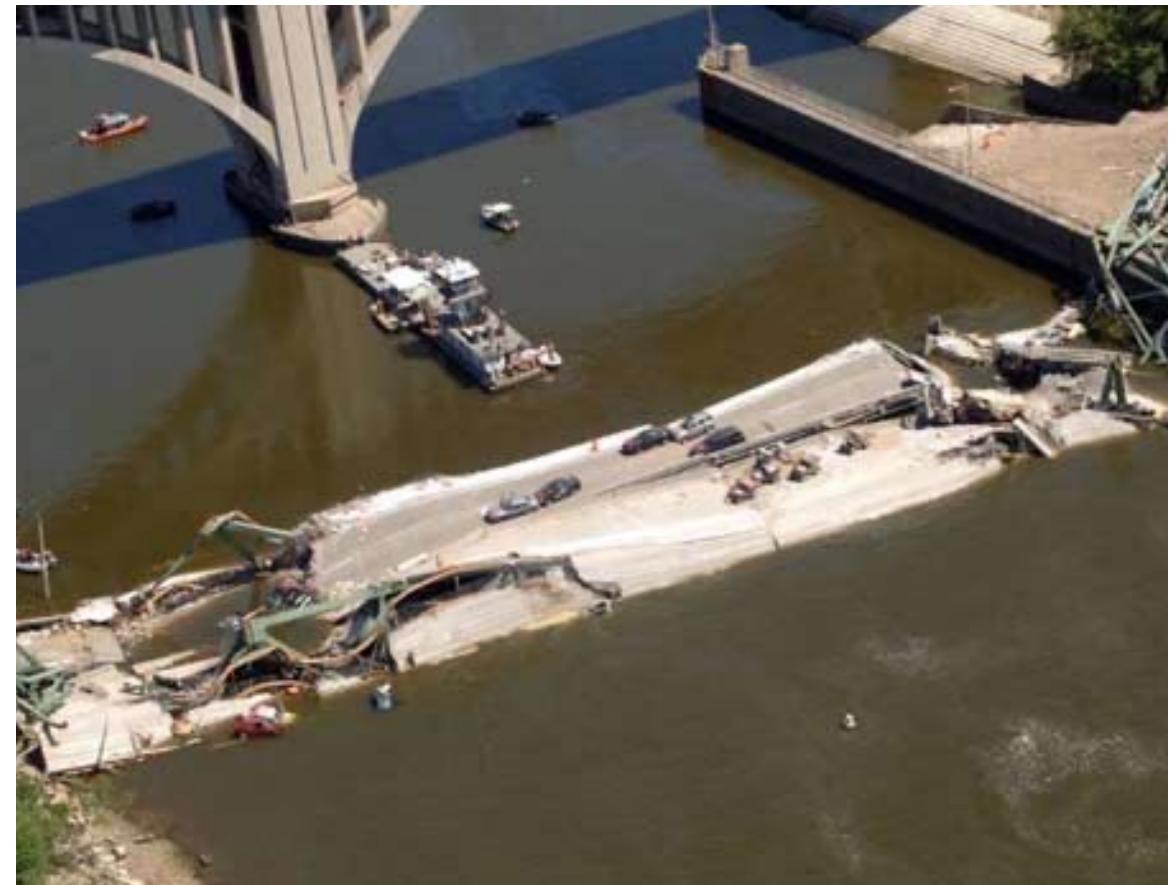
3. Additional load

- Renovation and repaving work increased bridge weight

Bridge collapsed during repaving^[2]

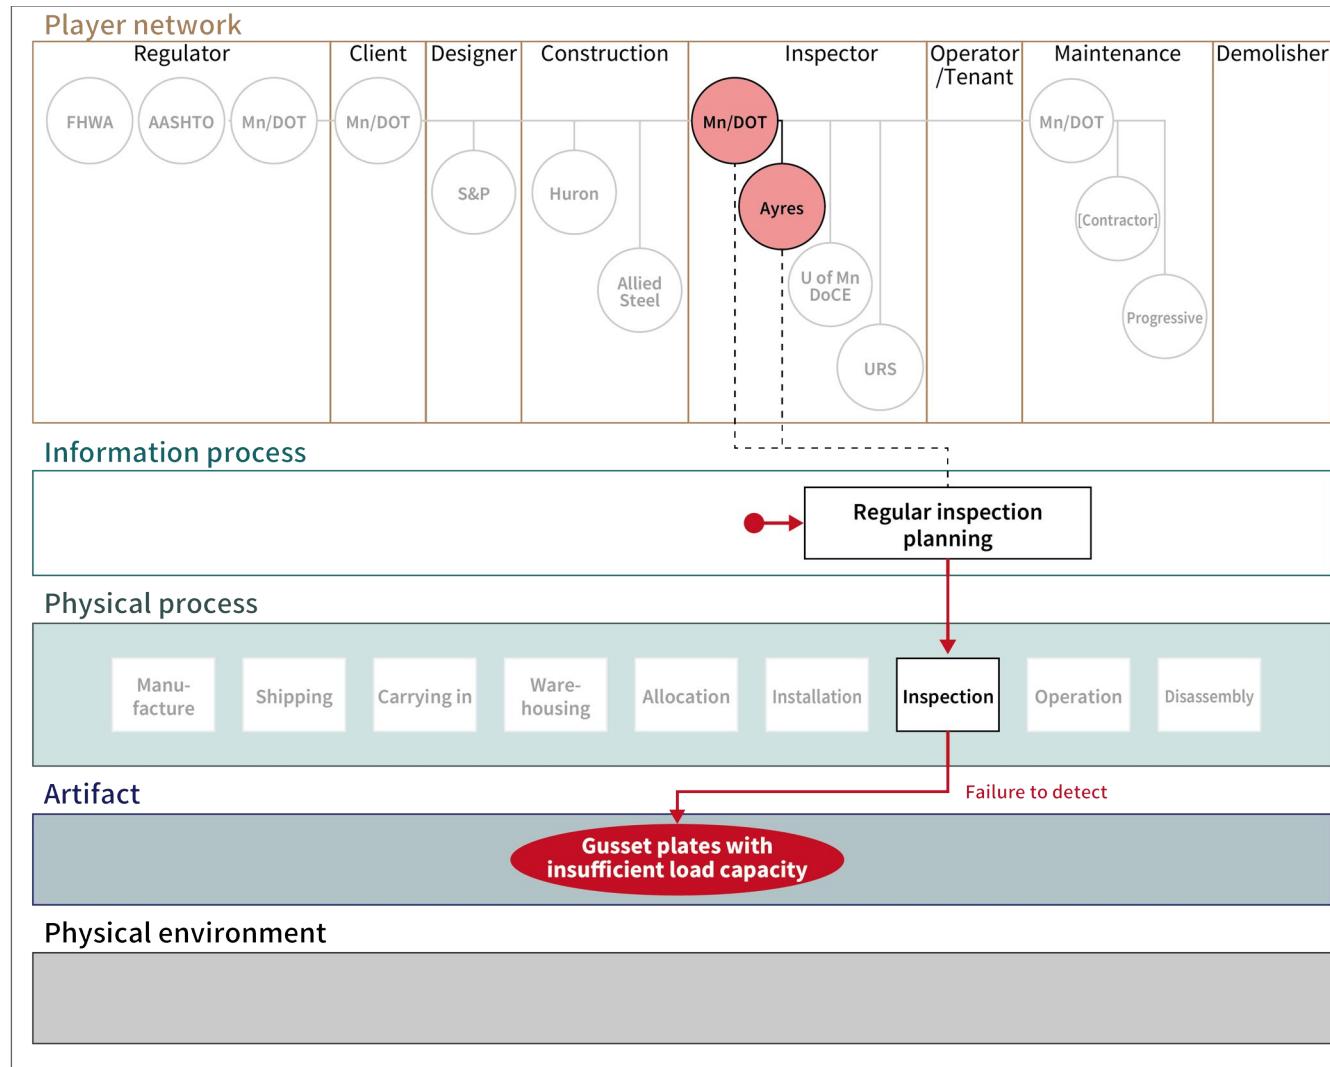
Required inspections repeatedly failing to detect defective gusset plate design

- Required annual inspections 1971-2007
- Gusset plates excluded from inspection guidelines
- Inspection work executed according to the guidelines
- Failing to detect the flaw in the gusset plates for ~40 years

Frame 14 Required inspections repeatedly failing to detect the inadequate design

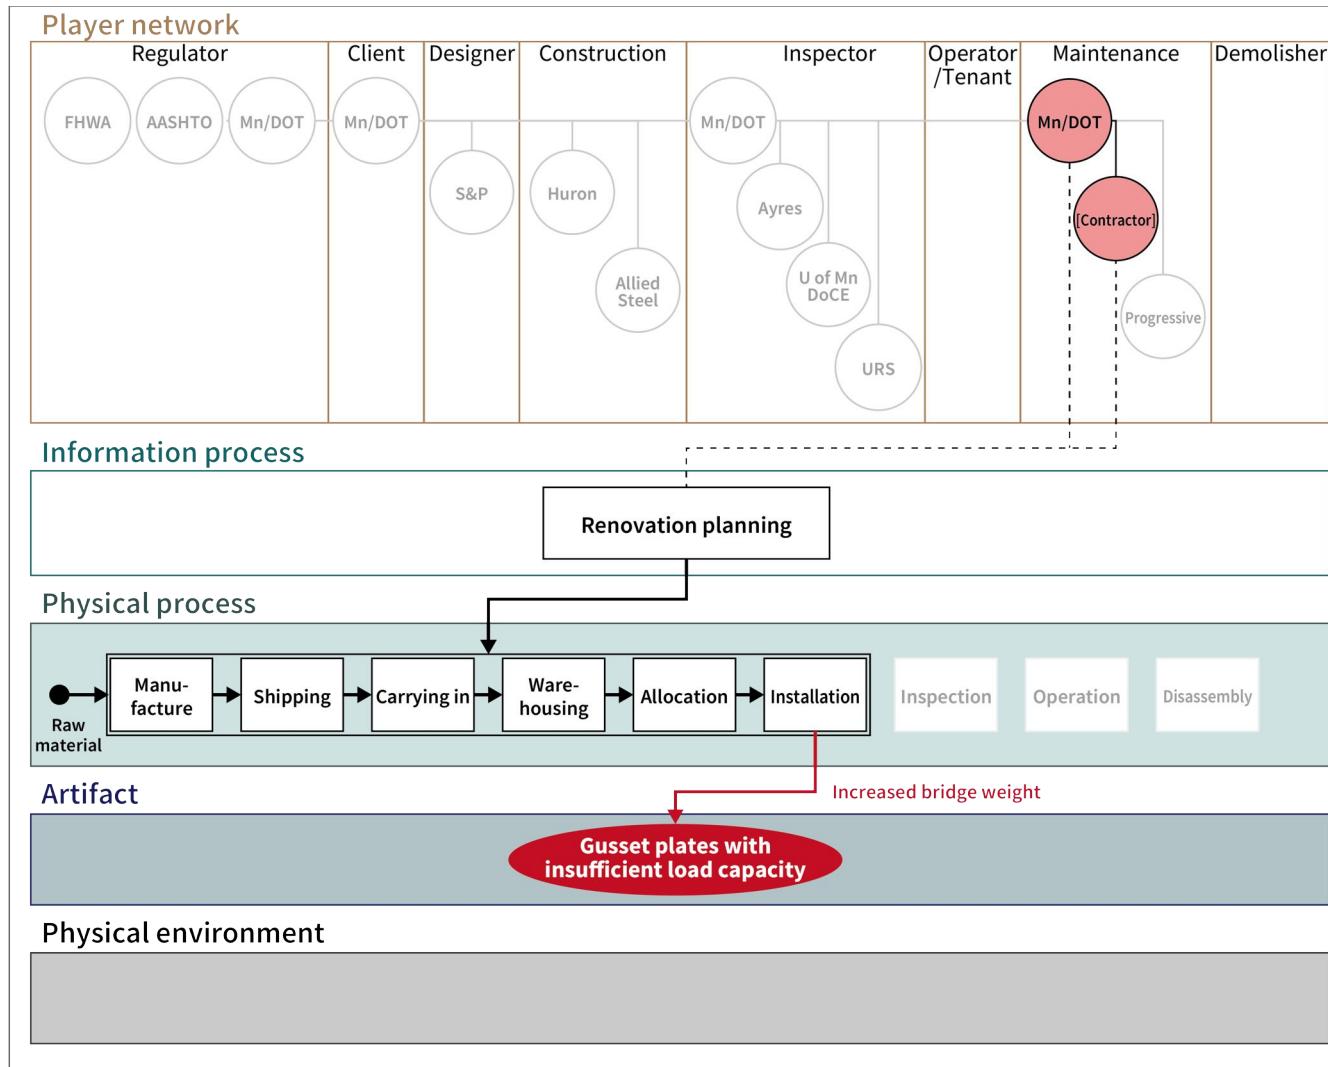
Renovation increased deck thickness

- Renovation work in 1977, 1998
- Addition of median barriers, traffic railings & anti-icing system
- Both increased the weight of the bridge for justifiable purposes
- Unknowingly worsened the situation

Frame 9 Renovation increased deck thickness (1977)

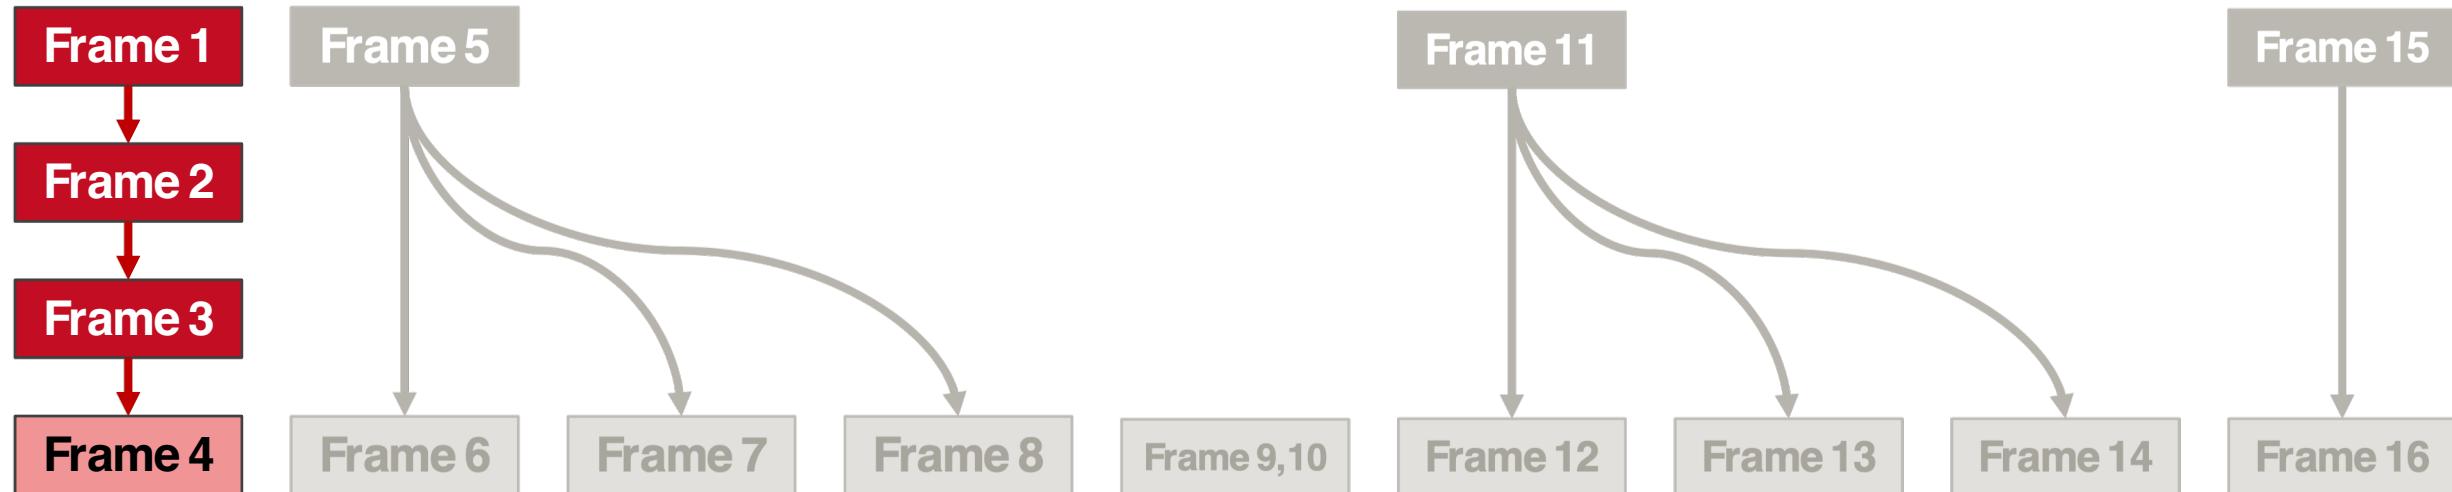
Initial injection: Defectively designed gusset plates fabricated and installed on the bridge

Frame 1 Inappropriate structural calculations, not in accordance with regulations

Frame 2 Inadequate internal design quality control

Frame 3 Inadequate regulatory design review procedures

Frame 4 Fabricated and installed as specified

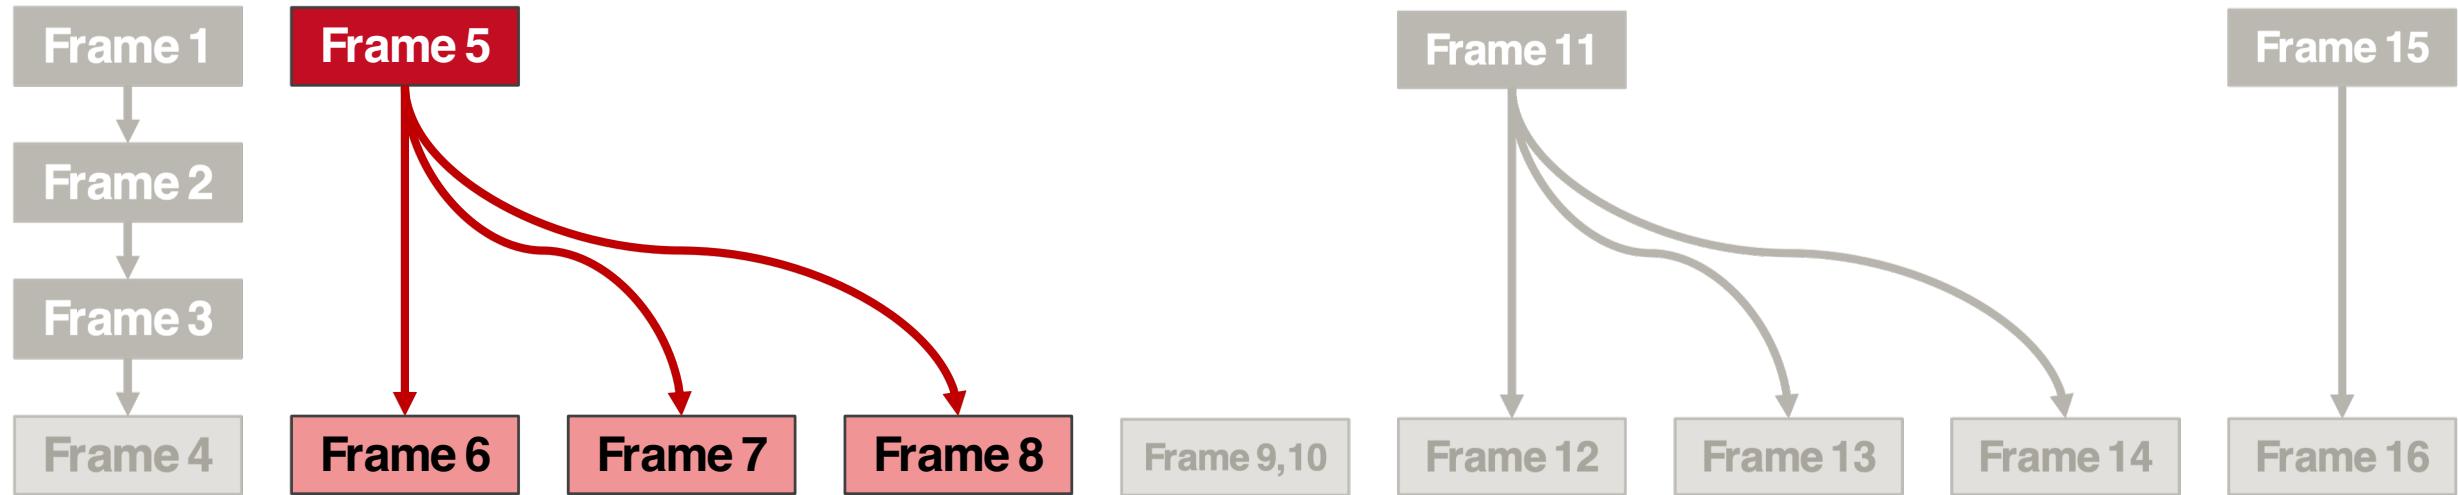
Pathogen exposure: Failed bridge load rating before and after opening to public

Frame 5 Inadequate load rating requirements

Frame 6 Failing to conduct load rating before bridge opening

Frame 7 Bridge load rating failing to address gusset plates (1979)

Frame 8 Bridge load rating failing to address gusset plates (1998)

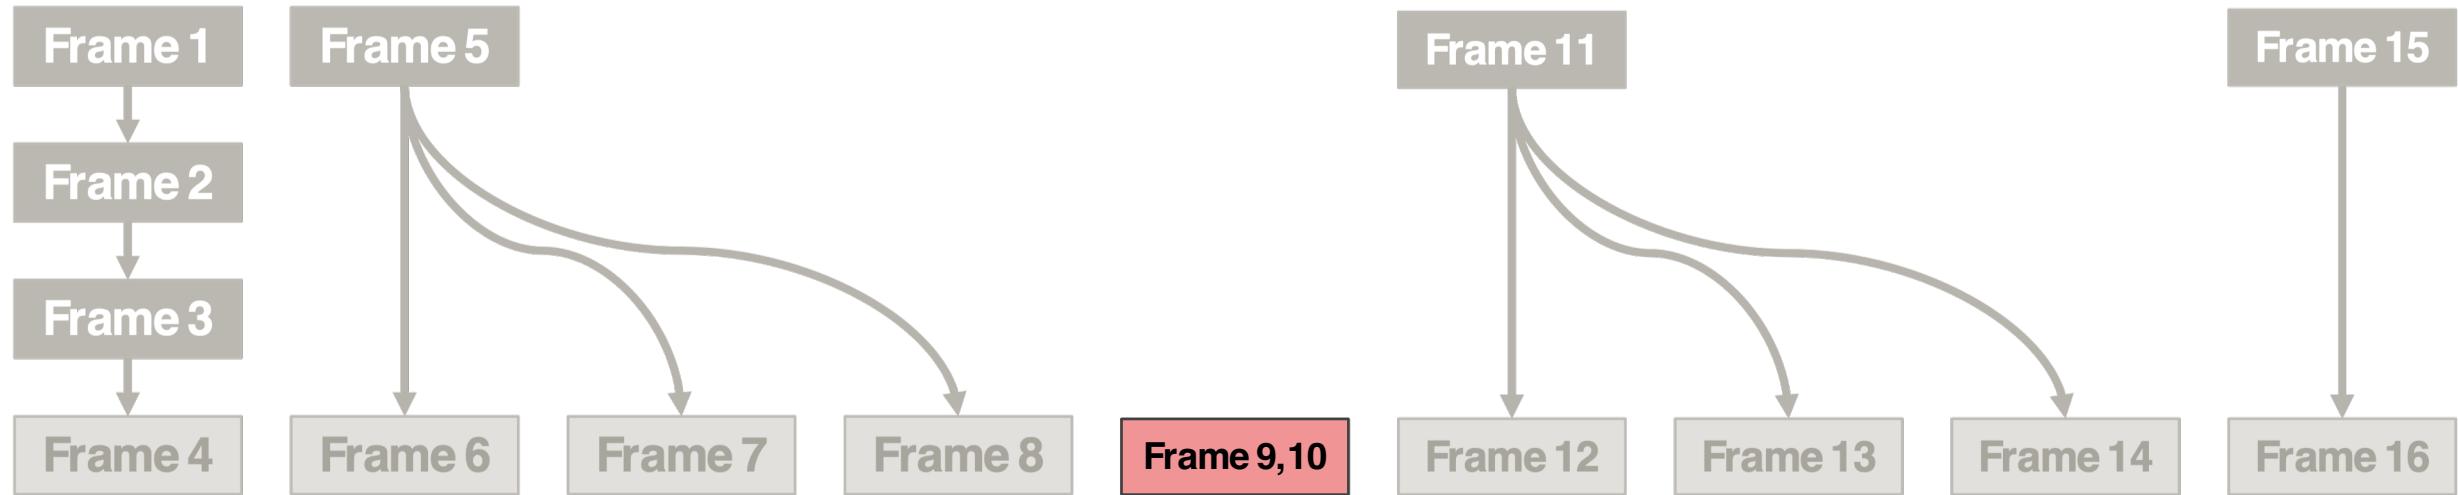
Well-intended aggregation: Renovation work unknowingly increased bridge weight

Frame 10 Renovation increased dead load with median barrier, traffic railings & anti-icing system (1998)

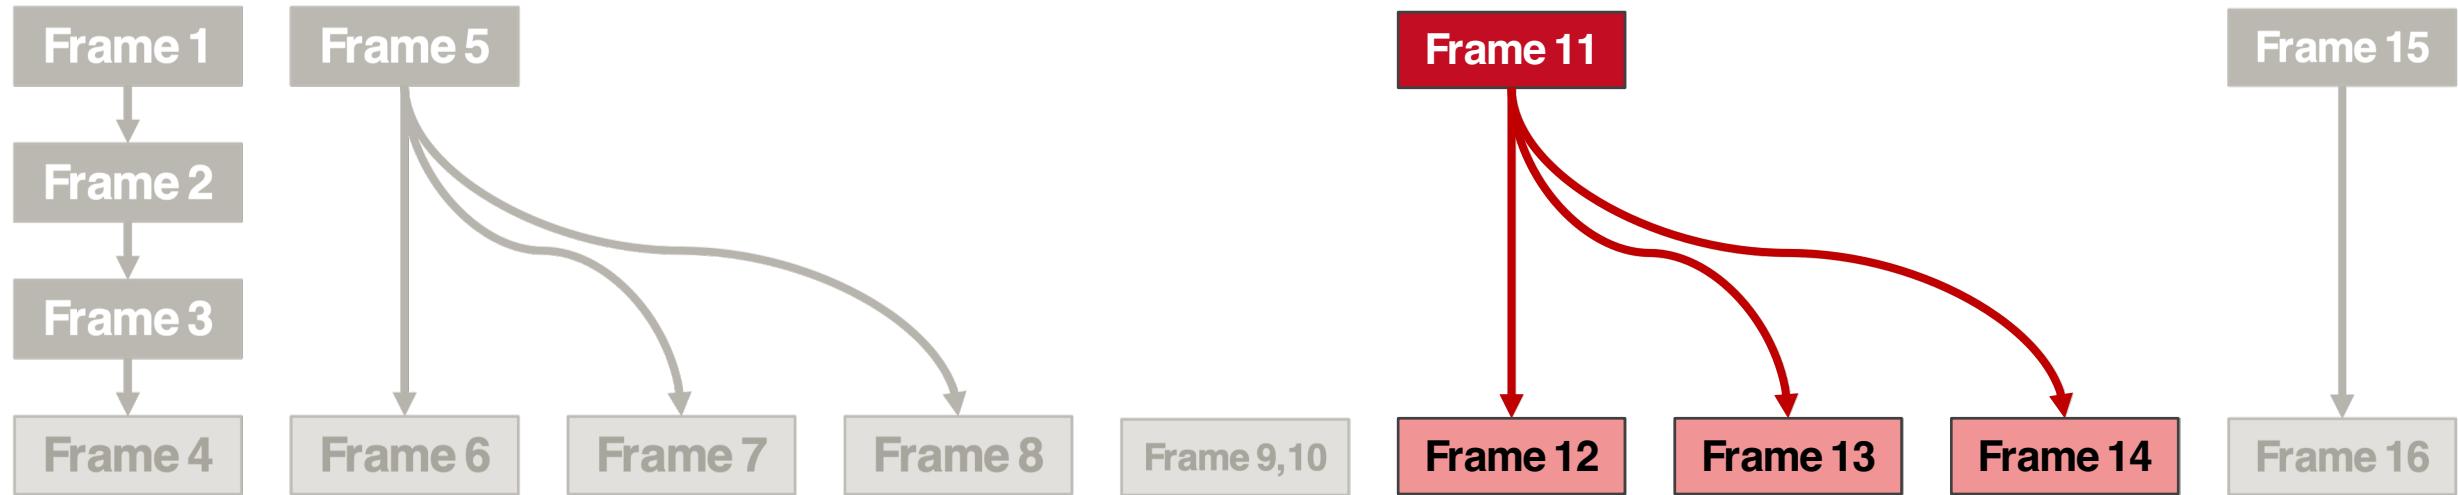
Missed opportunities: Routine inspections failing to detect flawed gusset plates

Frame 11 Absence of gusset plates in inspection guidelines

Frame 12 Fatigue assessment not including gusset plates

Frame 13 Fatigue evaluation only inspecting gusset plates via visual methods

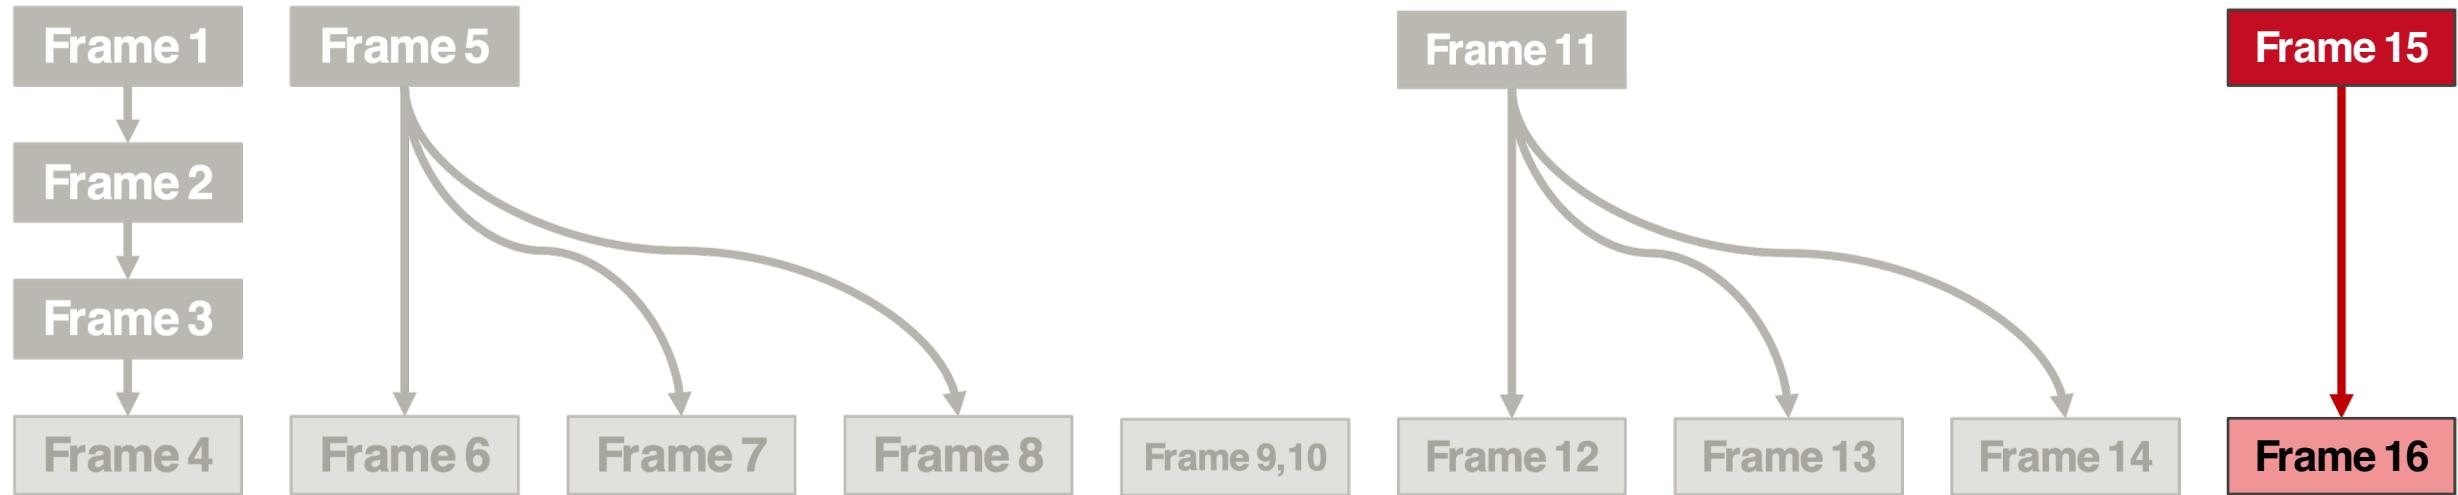
Pathogen activation: Repaving work added weight, triggering the collapse

Frame 15 Lack of appropriate guidance for construction material storage on bridges

Frame 16 Repaving work with insufficient consideration of load concentration
